Report No. IITRI-M6061-15

CREEP-RUPTURE BEHAVIOR OF IRON
SUPERALLOYS IN HIGH-PRESSURE HYDROGEN

S. Bhattacharyya
IIT Research Institute
10 West 35 Street
Chicago, Illinois 60616

Fifth Quarterly Narrative Report Covering
Period 1 October to 31 December 1980

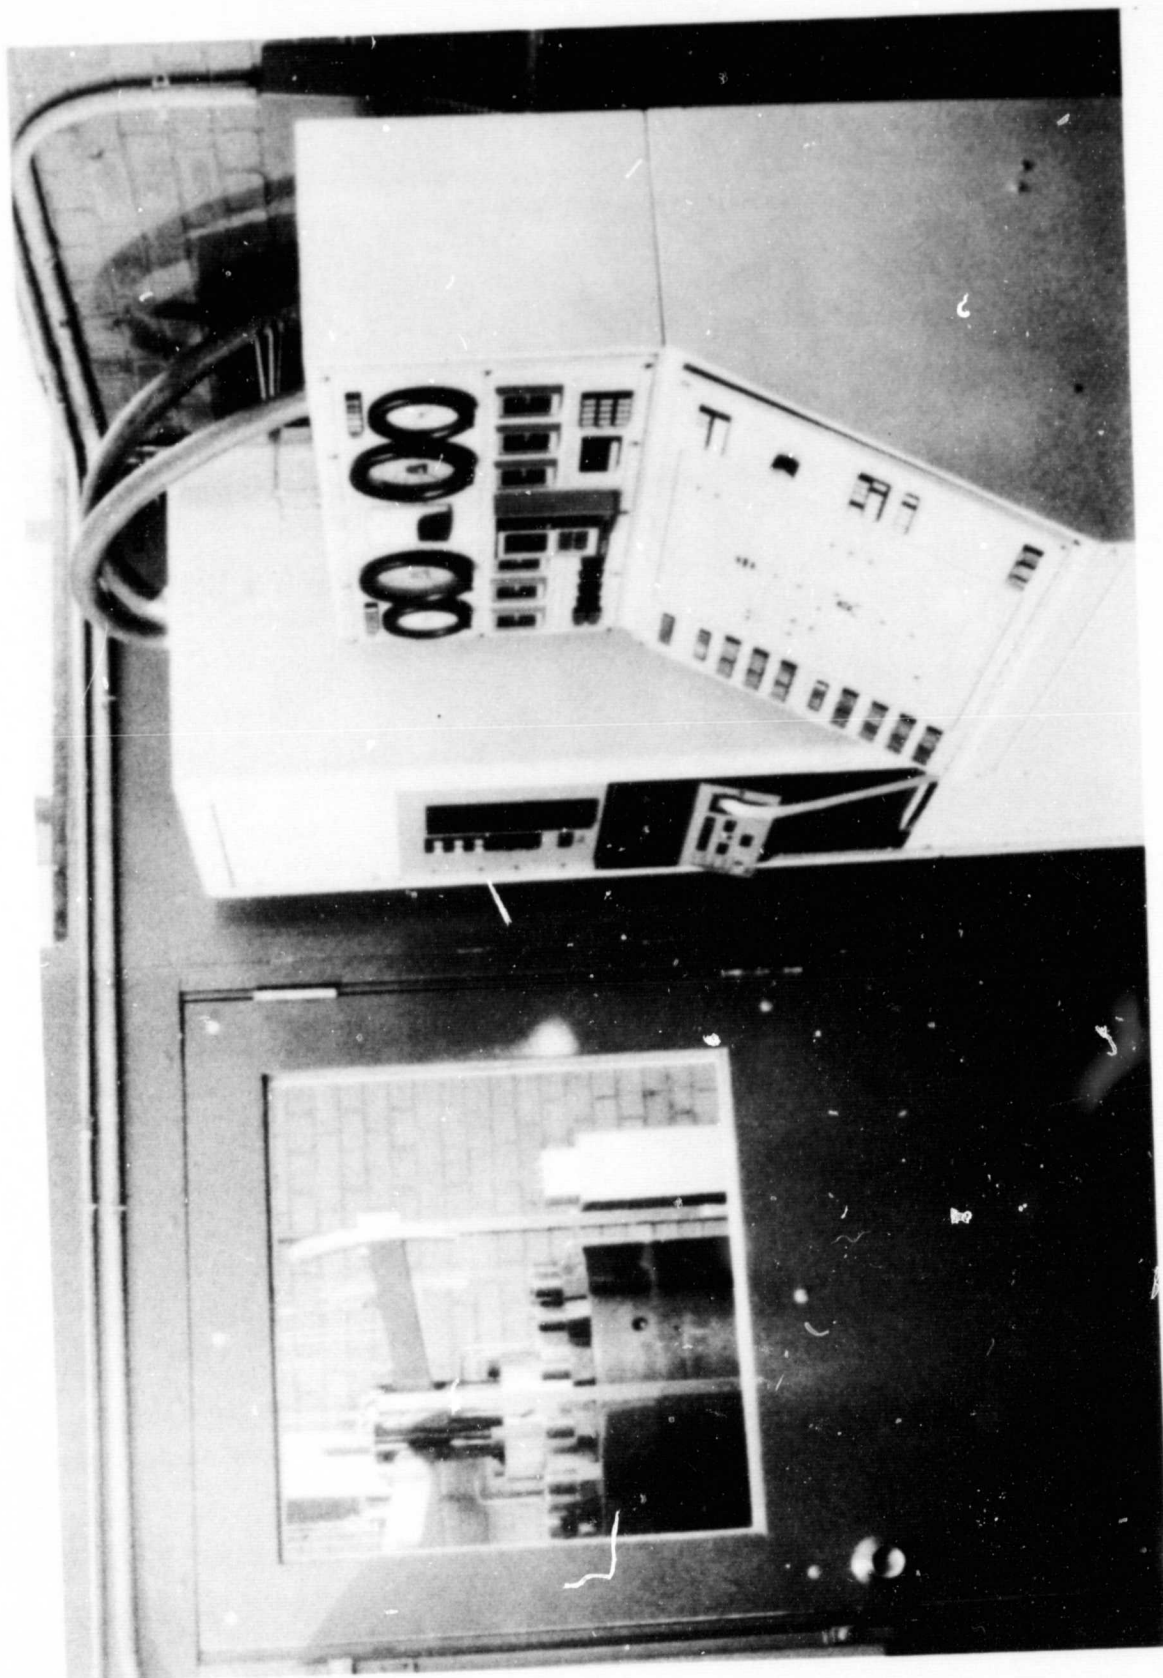
Figure 5
View of the Test Chamber with the Pressure Vessel Inside
and the Control Panel and Data Logger Outside

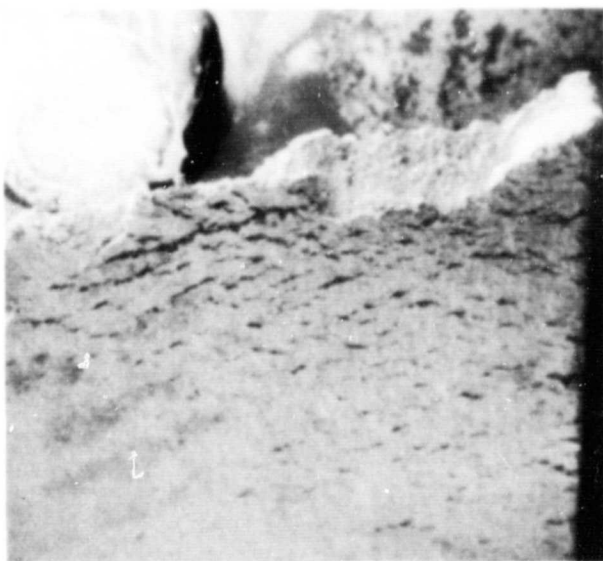
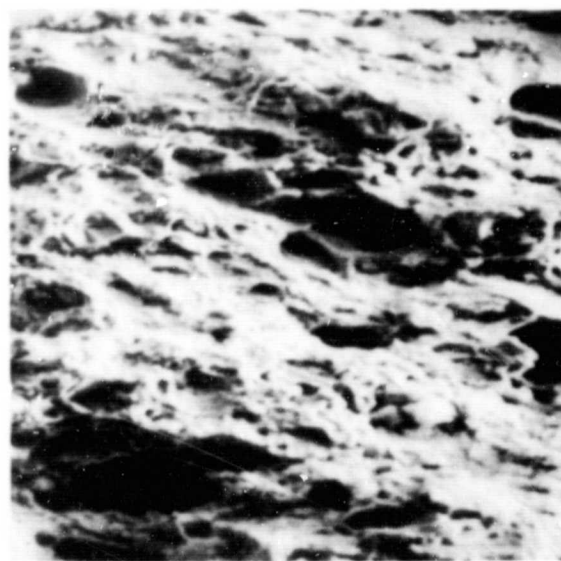
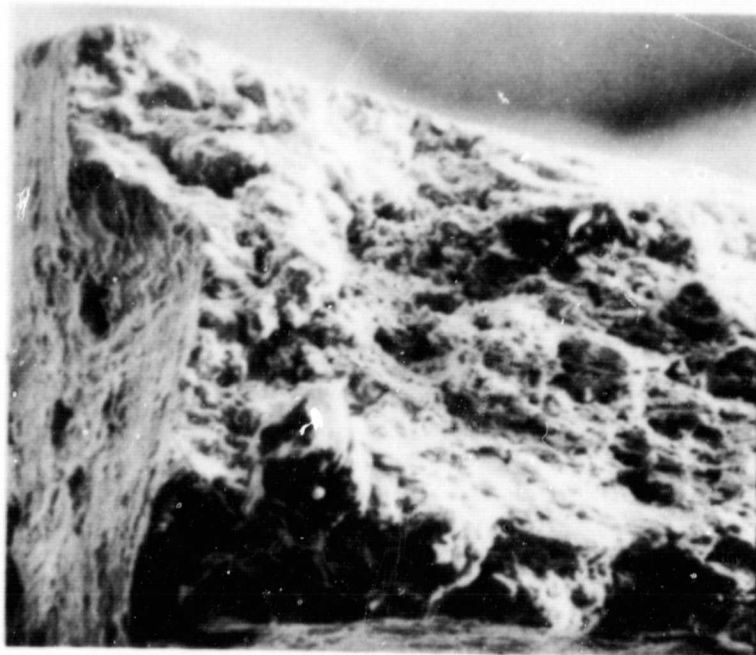
Figure 24

Typical fracture features of 19-9DL alloy specimen creep rupture tested at 815°C and 124 MPa are shown in Fig. 24. Figure 24a (A and B) shows low-magnification macrofractographs of the two mating surfaces. This fracture also seemed to have originated at multiple locations (surface cracks) near the outer edges of the specimen cross-section. Rough topography of the

Typical Macro- and Microfractographs of the 19-9DL Specimen Creep Rupture Tested at 815°C and 124 MPa. (a) Macrofractographs of the mating surfaces; (b) side view of the fracture surface shown in Fig. 24a (B); and microfractographs of areas in Fig. 24a (B); (c) central region of the specimen surface, (d,e) area at upper left corner, and (f) region near right end.

fracture and abundance of surface cracks are clearly seen in Fig. 24b, which gives a side view of the fracture shown in Fig. 24a (B). In the central region of the fracture surface (Fig. 24a, B), the fracture occurred primarily by dimple rupture mechanism as illustrated in Fig. 24c. Both clusters of small equiaxed dimples separated by larger elongated dimples containing precipitate particles and inclusions cover the entire area. The area in Fig. 24c also shows some surface oxides that were formed subsequent to fracture. Near the left edge of the specimen (Fig. 24c, B), the fracture appeared very rough and heavily oxidized (Figs. 24d and e), but the main fracture mode was dimple rupture. Formation of heavy surface oxides indicates that the separation of fracture surfaces started in the region shown in Fig. 24d and e. At the right end of the fracture surface in Fig. 24a (B), the main fracture features observed were small elongated dimples with very little surface oxide (Fig. 24f), indicating that the final separation of fracture surfaces occurred near the right end. Gradual decrease in oxidation from the left end to the right end of the fracture surfaces reveals the path followed by fracture. Absence of surface oxides in the final separation zone on the right side (Fig. 24a, B) may be due to the fact that after the separation of fracture surfaces this area was exposed to air at high temperature for a relatively shorter time period.

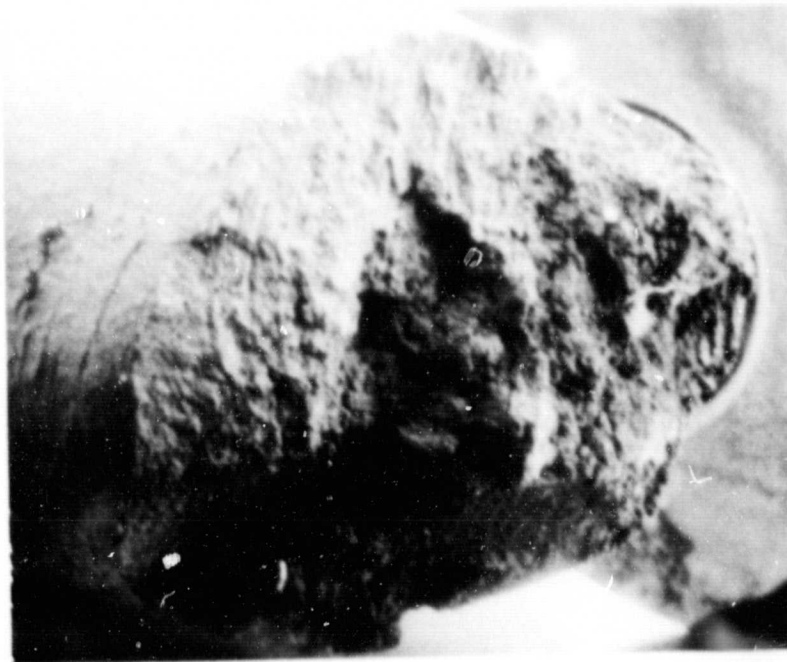
Figure 26 (cont.)

Figures 26a and b show low-magnification SEM macrofractographs of the mating fracture surfaces from XF-818 alloy specimen tested at 815°C and 138 MPa. This fracture apparently initiated at the edge of the specimen, areas a and b of Fig. 26a, where the fracture was relatively smoother and fine textured. The entire fracture displayed a jagged topography, and the areas c and d (Fig. 26a) were rough in appearance. The final separation occurred near the center of the specimen. Figure 26c shows a side view of the fracture surface shown in Fig. 26a. Many surface cracks which could act as initiation sites are clearly visible. In the initiation regions (areas a and b, Fig. 26a), the primary mode of fracture was dimple rupture (Fig. 26d). Figure 26d shows an area exhibiting a layer of fractured dendrites. The entire fracture surface was oxidized, especially areas c and d (Fig. 26a) where oxidation masked the entire fracture area. Figure 26e shows a microfractograph from the heavily oxidized area at the center of the specimen where the final separation seemed to have occurred.

Typical Macro- and Microfractographs of XF-818 Specimen Creep Rupture Tested at 815°C and 138 MPa. (a,b) Macrofractographs showing corresponding areas of mating fracture surfaces; (c) side view of fracture surface in (a); microfractographs from (a): (d) area a and (e) overload region in center.
